# DPRI-VMGD joint survey for Cyclone Pam damages

May 19, 2015

Disaster Prevention Research Institute, Kyoto University Kazuyoshi Nishijima Nobuhito Mori Tomohiro Yasuda Tomoya Shimura

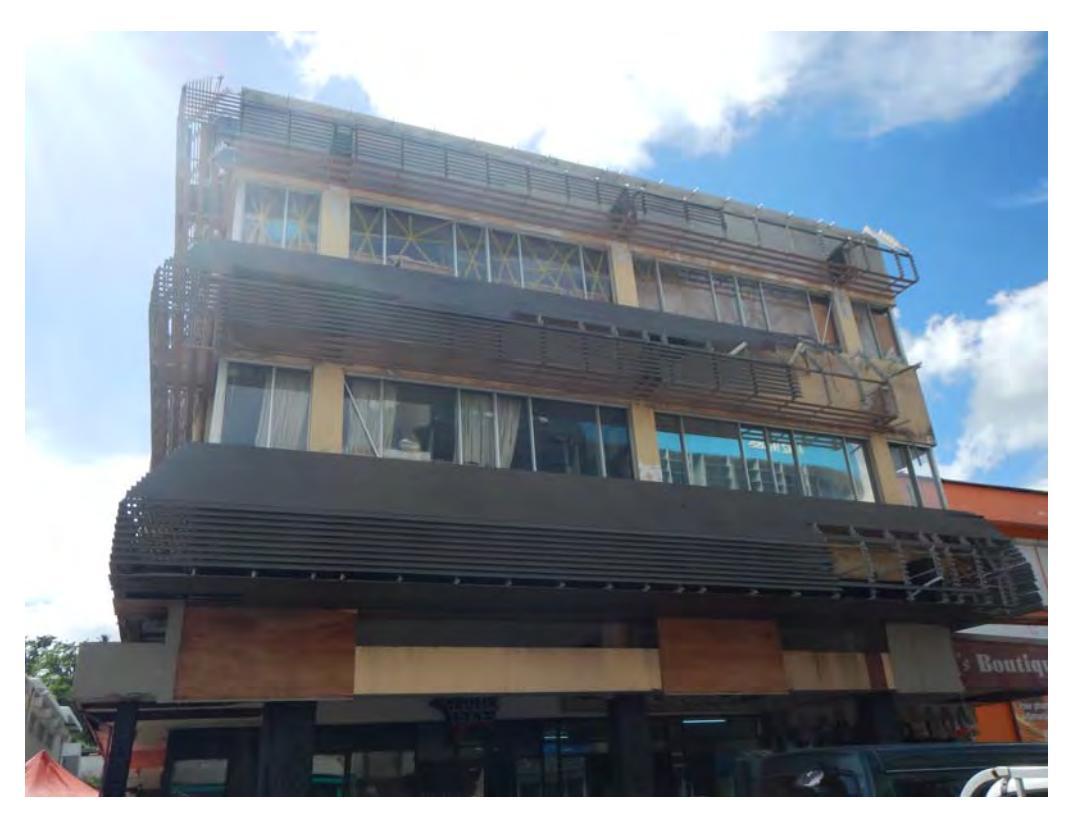
Most of the damages to RC structures seem limited to non-structural components such as envelops and interiors. The building in Figure 6 is a commercial building located in Port Villa, Efate Island. As seen, the damages are limited to its envelop, part of which is believed damaged due to lack of shutters. Significant damages are also observed to interior such as ceilings and partitions. It should be noted that many commercial buildings in Port Vila are equipped with shutters, many of which seem undamaged. Generally speaking, quality of construction work is good; however, several buildings with low quality construction were observed.

Figure 6. Damages to envelop of commercial building in Efate Island.

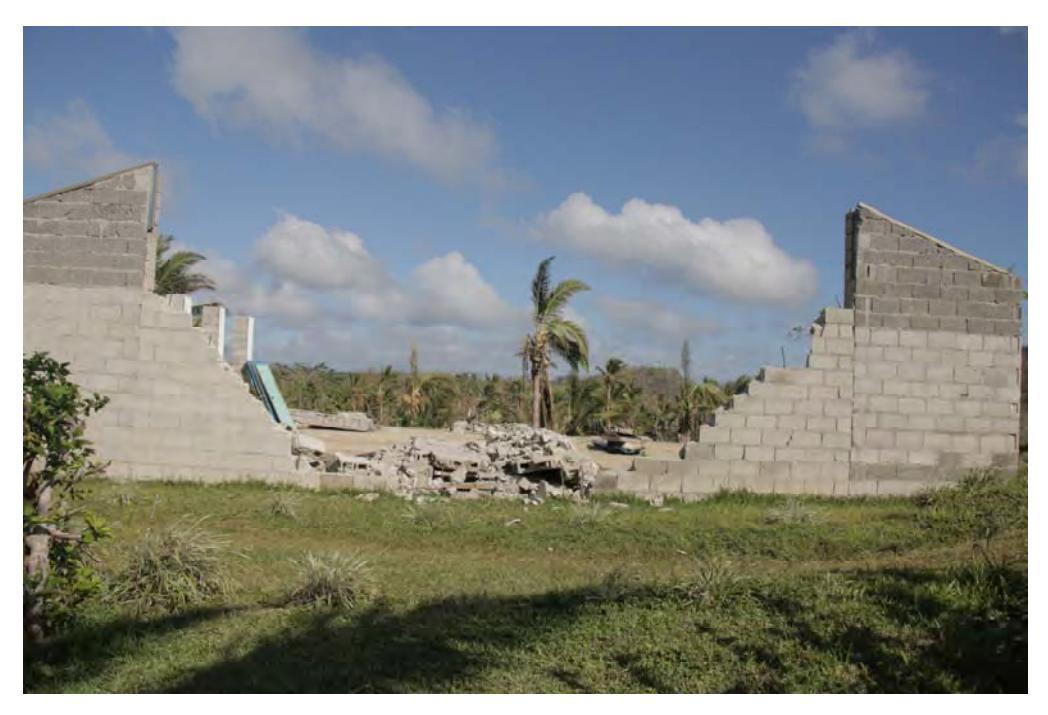
Collapses of concrete block structures were also observed. The totally collapsed building seen in Figure 7 is located in Tanna Island. The mortar joints seem relatively weak, and amount of rebar few and it lacks stiffness. It had been used as church and in the event of the Cyclone Pam several people in the village first evacuated to the church.

Figure 7. Totally collapsed church in Green Hill in Tanna Island.

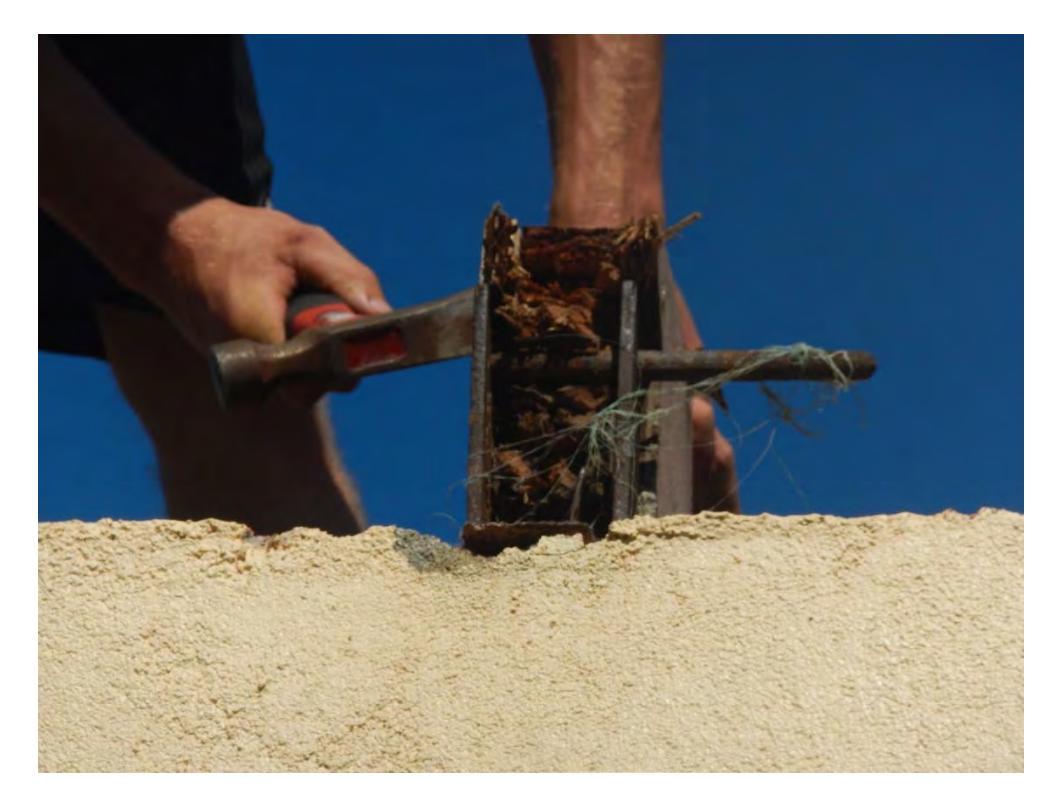
Significant deterioration of components were identified in many modern buildings that were damaged, see Figure 8. Steel connections are often rusted and un-treated timber products were deteriorated in those buildings.

Figure 8. Deteriorated component of damaged school building.

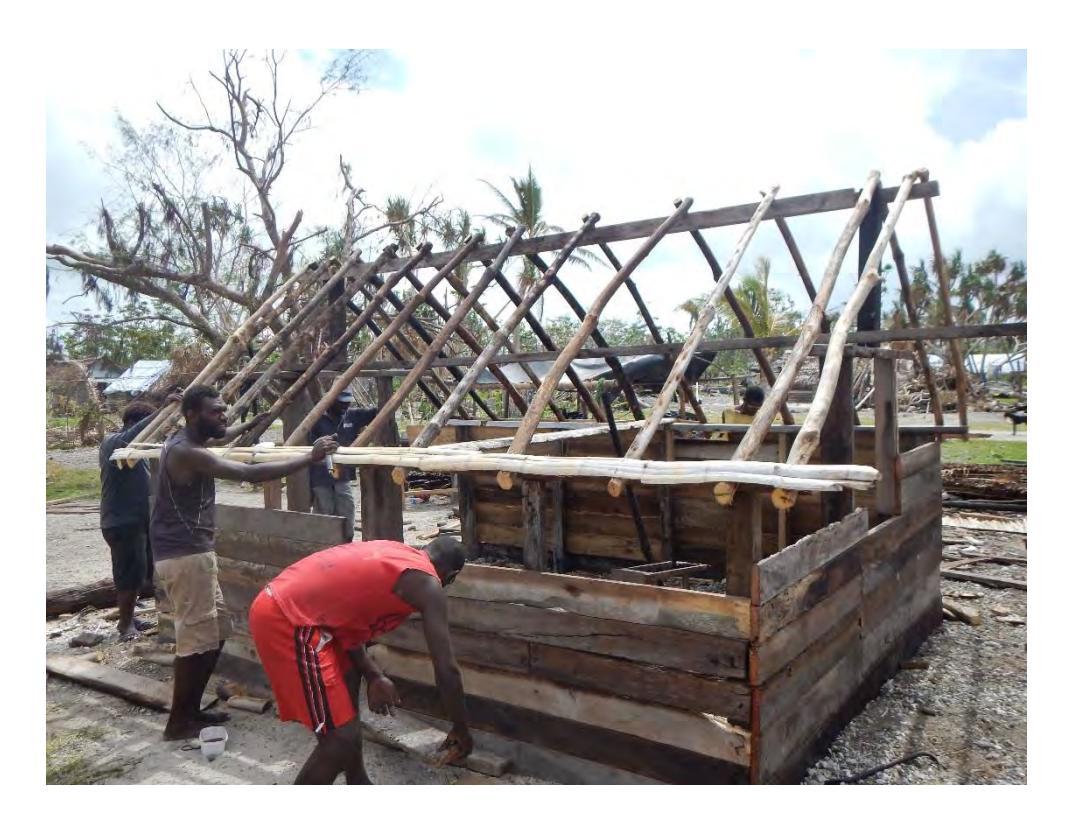
Figure 9. Traditional house under reconstruction at Eton, Efate Island.

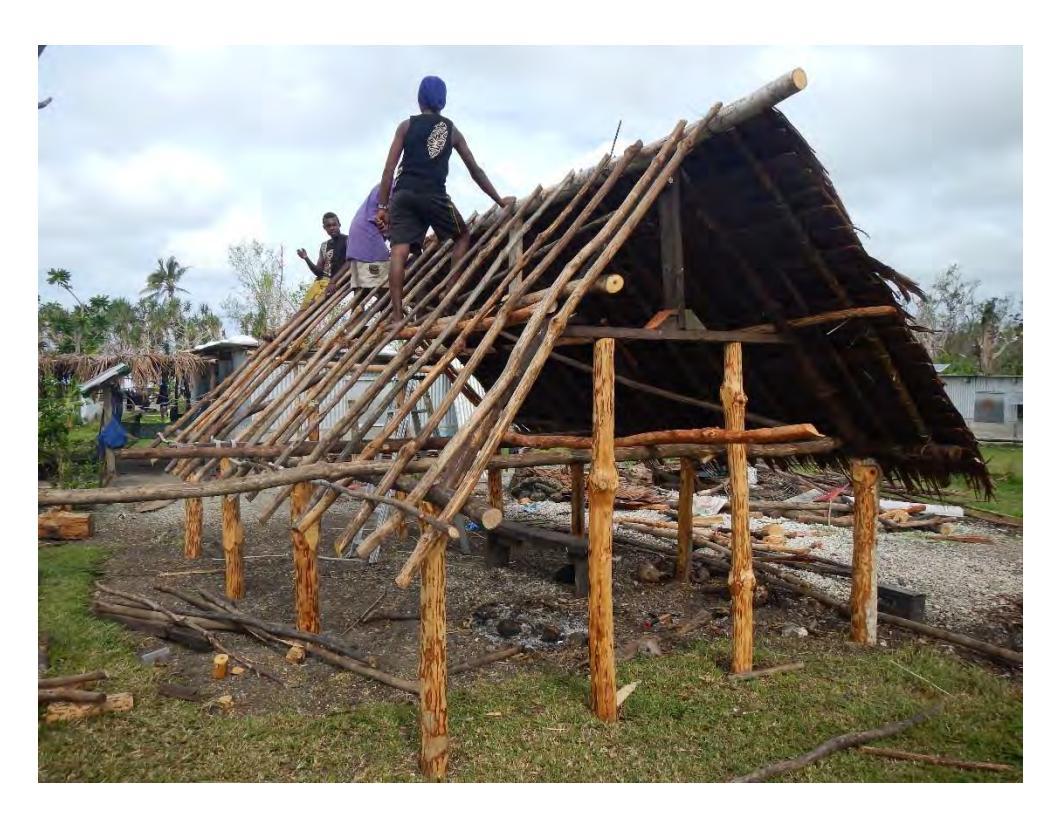
The house in Figure 10 has the dimension of 3140 mm in width, 2720 mm in height and 5270 mm in depth. It has narrow eaves. The columns are made of Mango tree. The diameter of the columns is around 120 mm and the columns are casted into the soil by around 500 mm. The rafters are made of Oak tree. The diameter of the rafters is around 60 mm. The ridgepole is made of a kind of nut tree. These trees were cut in the forest nearby, brought to the site and cut with a chain saw. For the connections nails are used.

Figure 10. Traditional house under reconstruction at Epao, Efate Island.

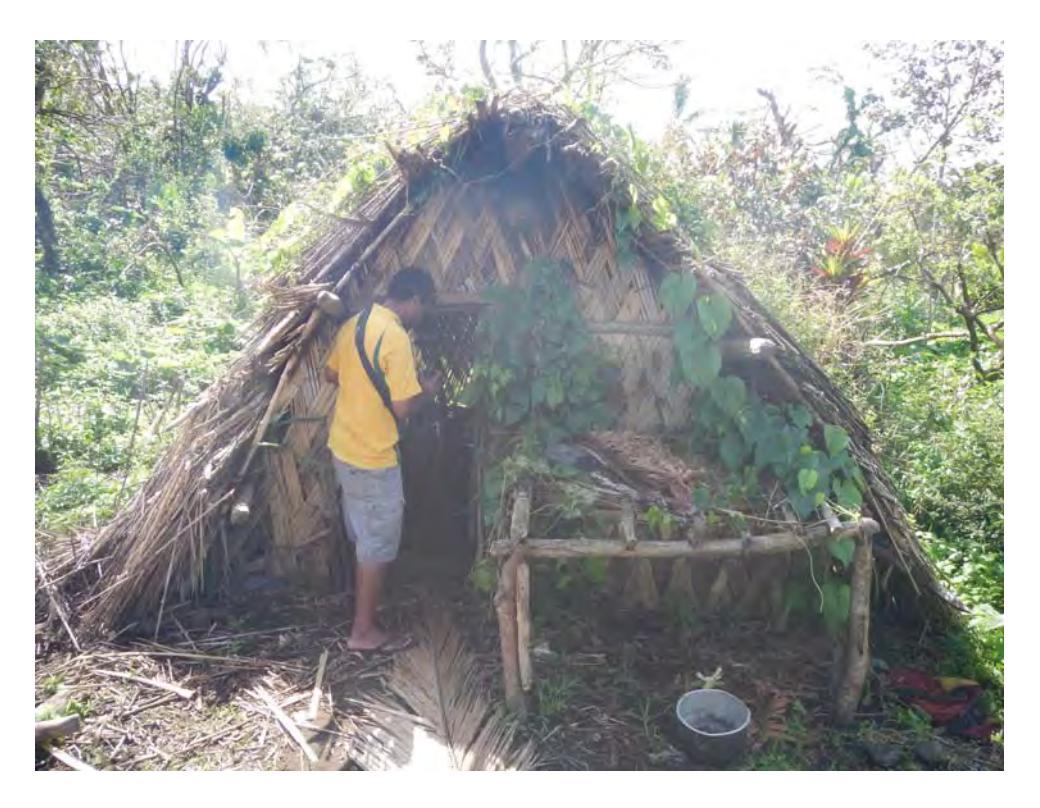
There are several testimonies that people in villages in Tanna Island evacuated to traditional cyclone shelters and those shelters did not fail during the cyclone. Figure 11 shows an example of the traditional cyclone shelter in Tanna Island and Figure 12 shows a traditional cyclone shelter that are being built after Cyclone Pam. Although the dimensions and details are diverse, there is a common characteristics in the traditional cyclone shelter. That is, the roof is extended to the ground. The shape seems empirically optimized to best resist against strong wind.

Figure 11. Traditional cyclone shelter at Yakel in Tanna Island.

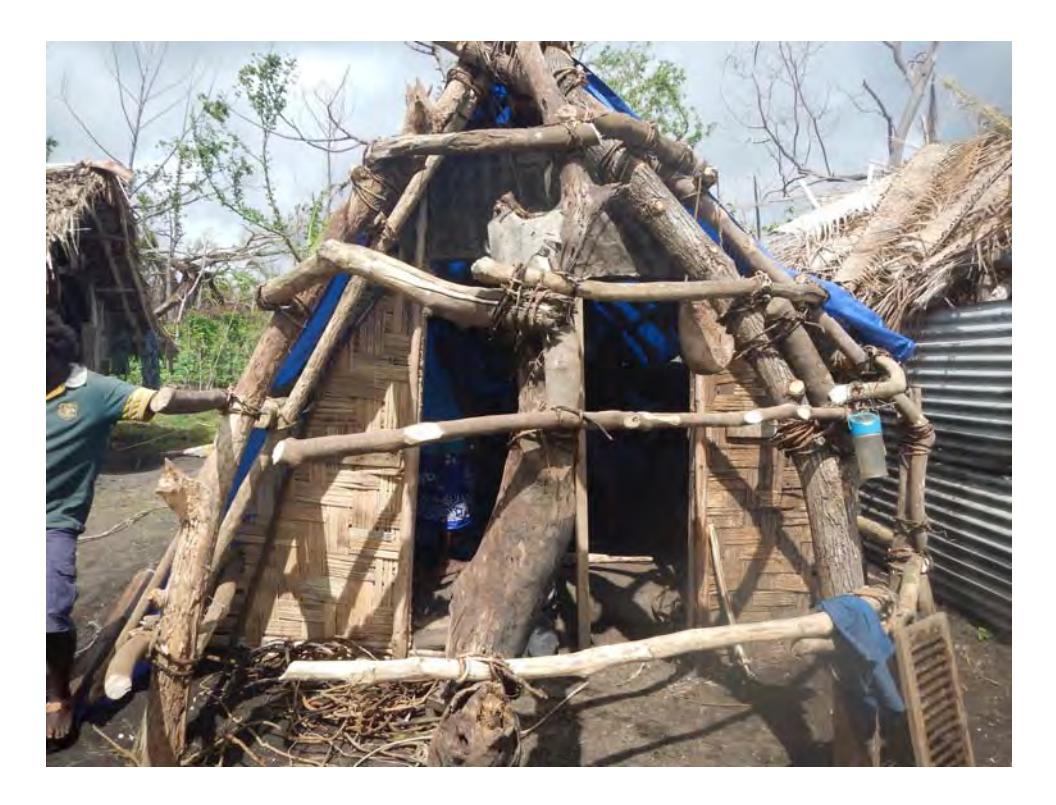
Figure 12. Newly constructed traditional cyclone shelter at Loutapunga in Tanna Island.

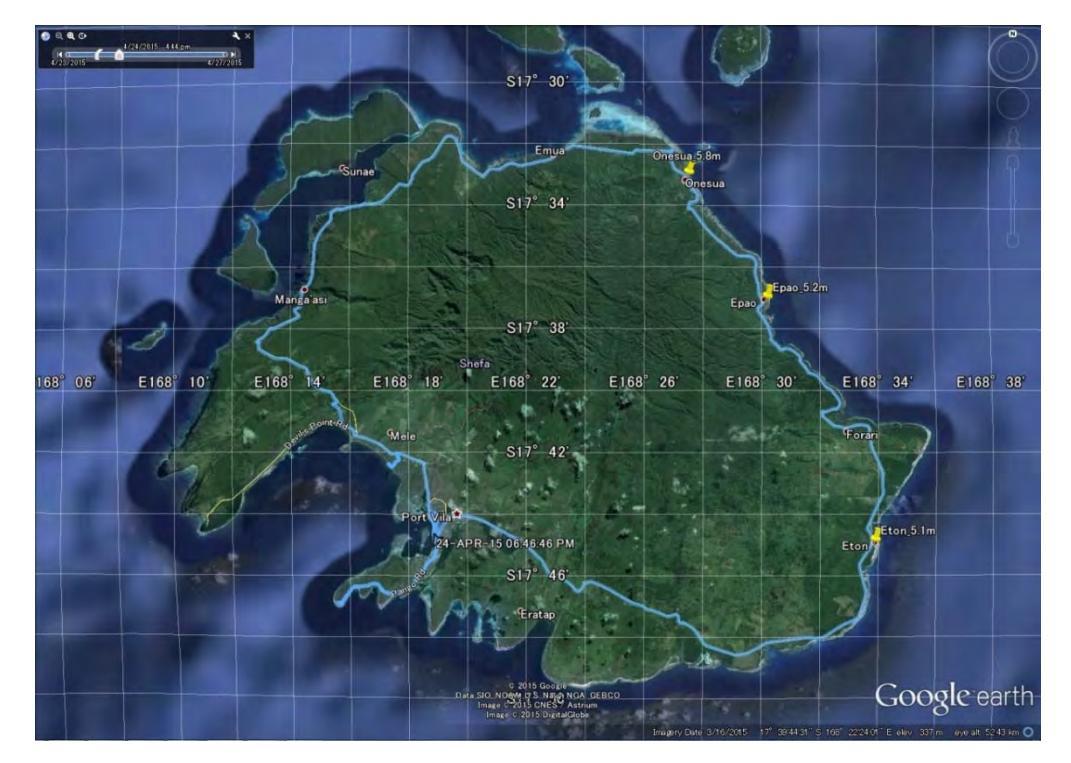
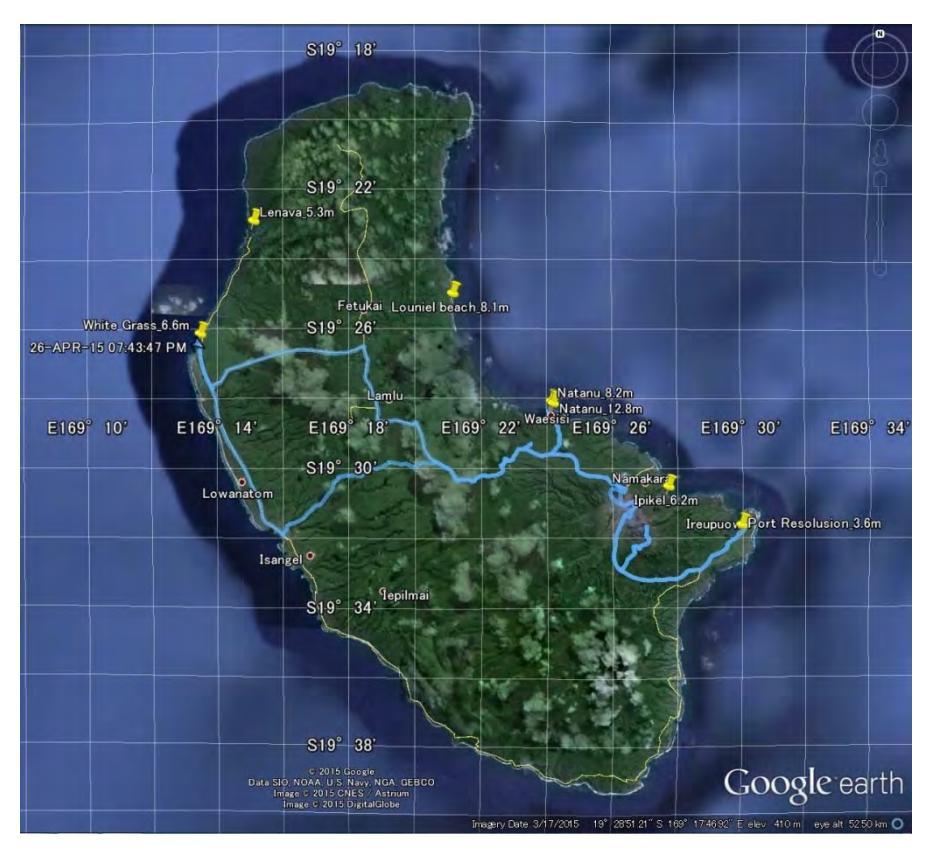
Wave run-up and inundation heights were measured according to interview to local residents by an auto-level and a laser range finder. The survey was follows protocol of the post-tsunami survey field guide by IOC. Figure 13 displays the survey results in Efate Island and Tanna Island. In Efate Island, coastal inundation was mainly observed along the east coasts, e.g. Eton, Epao, and Onesua, and the maximum run-up heights were about 5 m from the mean sea level (MSL) excluding tidal effects. In Tanna Island, inundation heights were larger than that of Efate due to larger offshore wave height shown in Figure 4. Along northwest coast of Tanna where the distance is close to the cyclone eye, 5–6 m run-up above MSL was observed at Lanava and White Grass. On the other hand, in the northeast coast of the island, large inundation which is 8 m was observed where the fetch was the longest without shading effects of islands. Severe beach cliff erosion was observed at Louniel beach, which height was about 6 m as shown in Figure 14. Several ships made of FRP were flown and run-up at Natanu, Waisisi. Inundation heights gradually decrease to south in the east coast due to shading of peninsula. At Ipikel facing the Sulfur bay, inundation height was about 6 m, and at the Port Resolution run-up height becomes less than 4 m. SPC report summarized that the satellite image of the North East of Erromango shows major coastal erosion and inundation. We observed similar phenomena by extreme waves in Tanna Island visually.

Figure 13. Measured run-up and inundation height from MWL (unit: m).

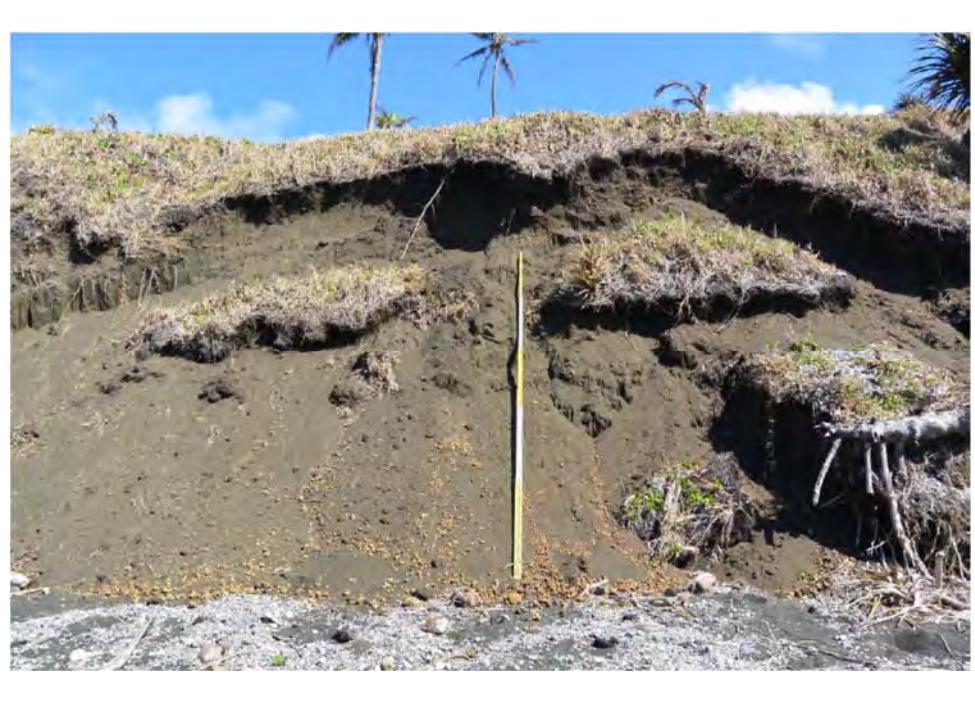
Figure 14. Sevier coastal cliff erosion at Louniel beach in Tanna Island.

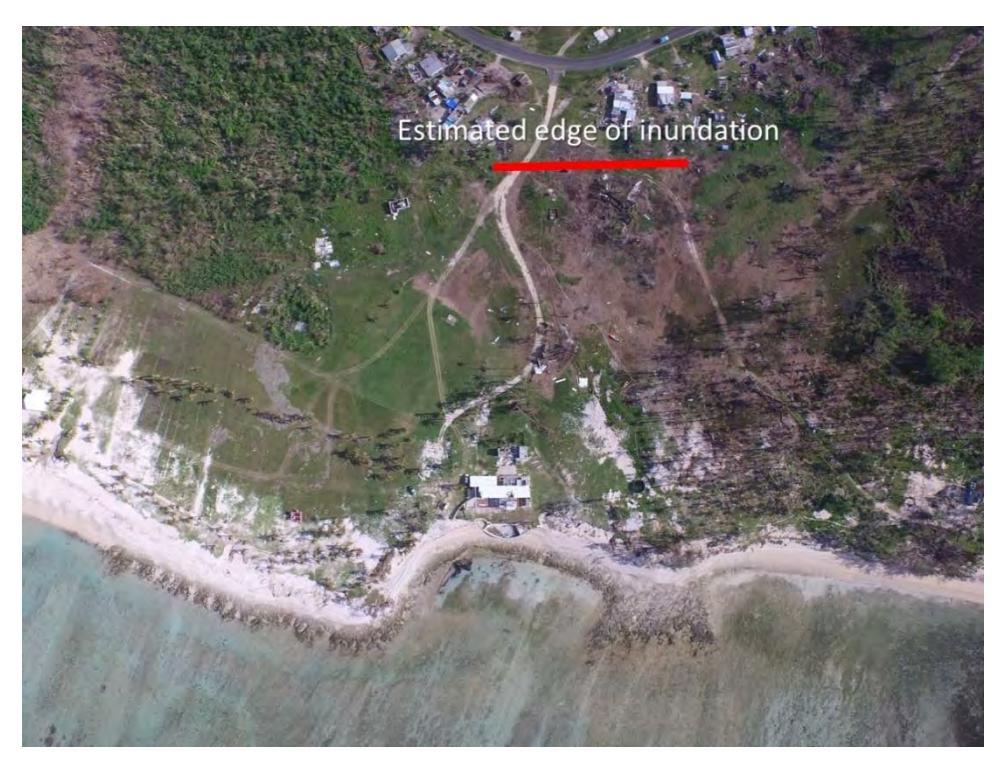
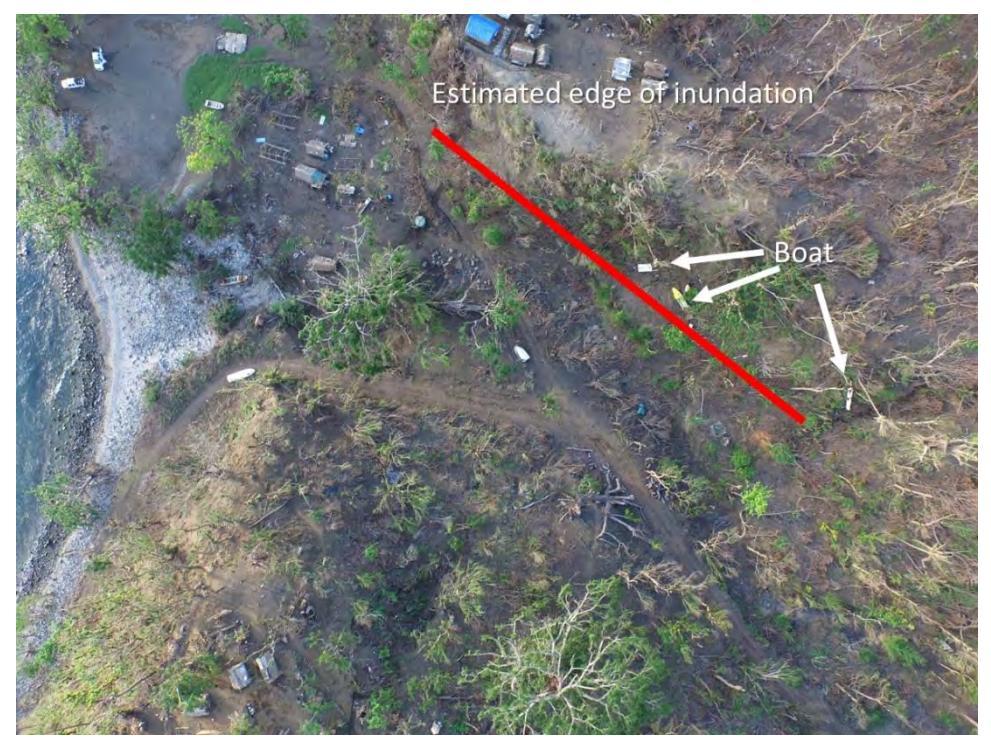
The long distance inundations were observed several locations. One example is Baofatu beach (Takara hot spring) at the northeast coast of Efate island. Figure 15 (a) shows aerial snapshot of observed coastal inundation by a drone. There are many boulders of coral rocks from the reef and concrete blocks from coastal walls until 100 m along the coast. The maximum distance of inundation is 300 m and it was remained more than 2 days according to witness evidence by local residence. The highest run-up of coastal flooding was observed at Waisisi village in southeast coast of Tanna Island (Figure 15 (c)). The maximum run-up height was about 12 m and propagated up to 300 m from the coast line. The severe coastal inundations are measured east coast of Tanna island that feature is matched with numerical hindcast shown in Figure 5.

Figure 15. Snapshot of observed coastal wave inundation by drone.
